**SOHO Mission Interruption Joint NASA/ESA
Investigation Board**

Final Report

**August 31, 1998
SOHO Mission Interruption Joint NASA/ESA
Investigation Board**

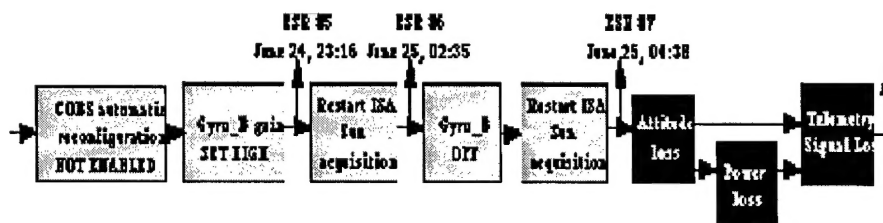
Diagram 1. Failure Event Tree - Top Level

The first two errors were contained in predefined command sequences executed from the Ground System, while the last error was a decision to send a command to the spacecraft in response to unexpected telemetry. The sequence of these errors and their relationship to the triggered-ESRs are graphically depicted in Diagram 1.

Since the gyro calibration in the compressed timeline is immediately followed by the execution of momentum management, the previously employed procedure to despin the gyros at the end of the gyro calibration and to re-enable the on-board software gyro control function was not required. Following gyro calibration, Gyro A was specifically deactivated (despun) in order to conserve its life, while Gyros B and C remained fully active. Due to an omission in the modified predefined command sequence actually used, the onboard software function that activates the gyro needed by ESR was not enabled. **This omission resulted in the removal of the functionality of the normal safe mode and ultimately caused the catastrophic sequence of events.**

Following the momentum management maneuver, Gyro B, which is used for fault detection, was erroneously left in its high gain setting, resulting in an indicated roll rate of 20 times greater than actual. **The incorrect gain was due to an error in another predefined command sequence; this error resulted in an on-board fault detection output that triggered an ESR.** This ESR, the 5th since launch, occurred at 7:16 PM EDT (23:16 UT), June 24, 1998.
